## Rhydydefaid No 2 slant (Commercial) Colliery railway embankment

NGR SS 6035 9215 to SS 6051 9252

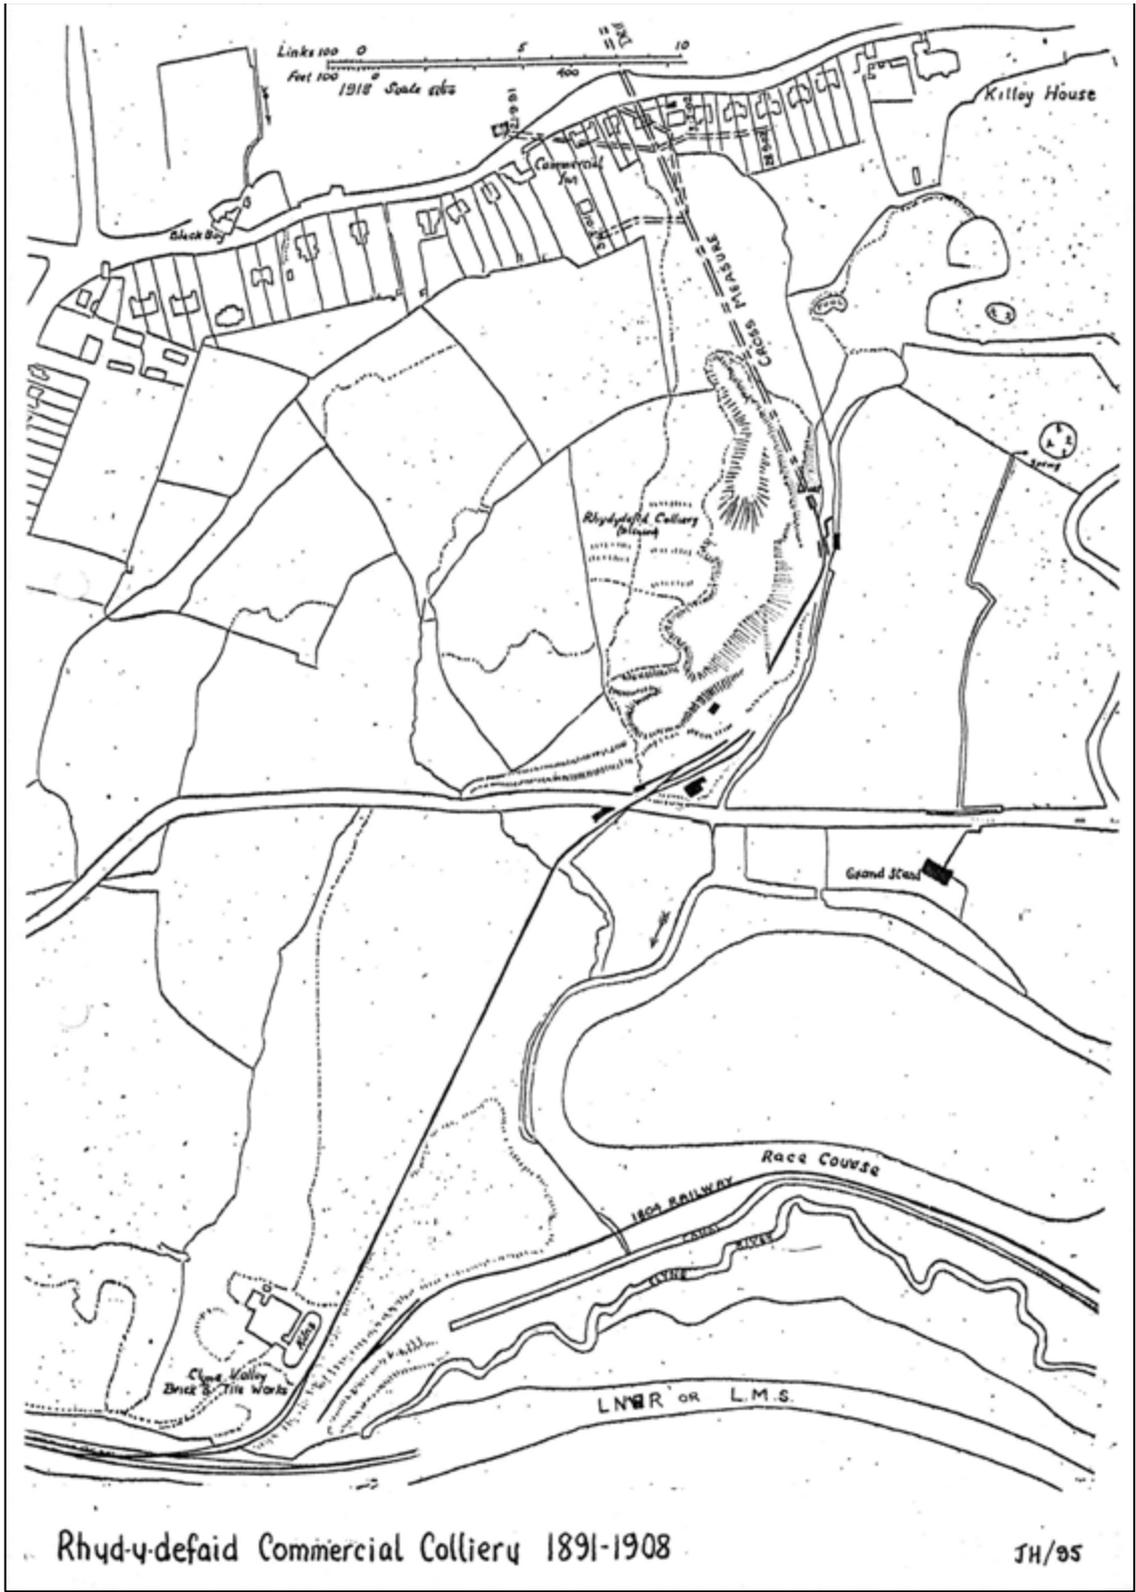
**Plan of Rhydydefaid No 2 (Commercial colliery)**  
 (Copied by the late John Hayman from the 1919 revision of the 25in Ordnance Survey plan)

The Commercial Colliery siding ran on an embankment in a straight line for most of its length from the end of the earlier Rhydydefaid No 1 siding to a point just south of the bridleway from the present-day Rhydydefaid Drive to Killay where it adopted a new alignment, crossed the bridleway and entered the colliery. Immediately to the south of the bridleway and on the north-west side of the railway there are remains of building which can best be interpreted as a weigh house to weigh the outgoing coal. Scattered pantile fragments are probably from the roof of the building; the word BRIDGEWATER, the place of manufacture, can be seen impressed on some of them. On the north side of the bridleway where it is crossed by the railway a rail can still be seen embedded in the side of a drainage ditch; another can be seen in the middle of the bridleway itself. A little to the east of this point a length of light-weight bridge-rail (of a type that would have been used underground) is fixed across the same ditch. The formation of the railway can be followed, although much overgrown, to the north of this point and alongside a wall which probably formed a tipping stage or retaining wall. Cartographic evidence suggests that this was the limit of the standard-gauge track.

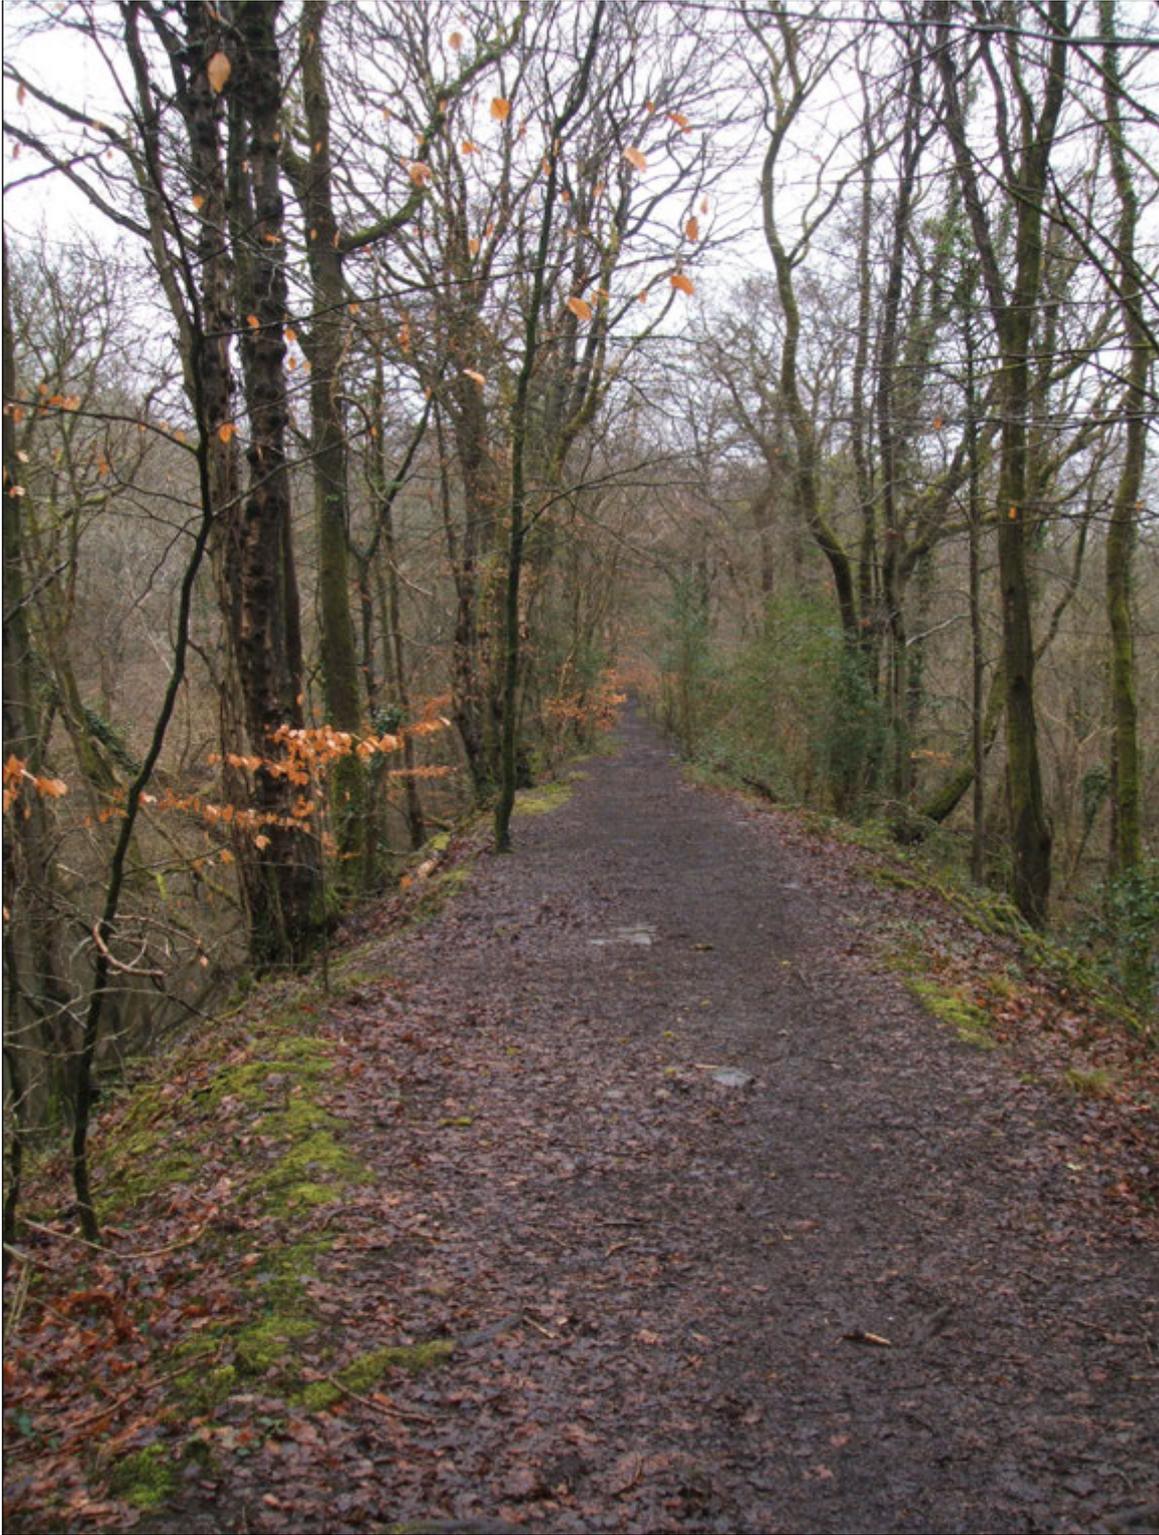
View along the embankment from Rhydydefaid No 1 towards Commercial, February 2012. (Photo C J Grigson)

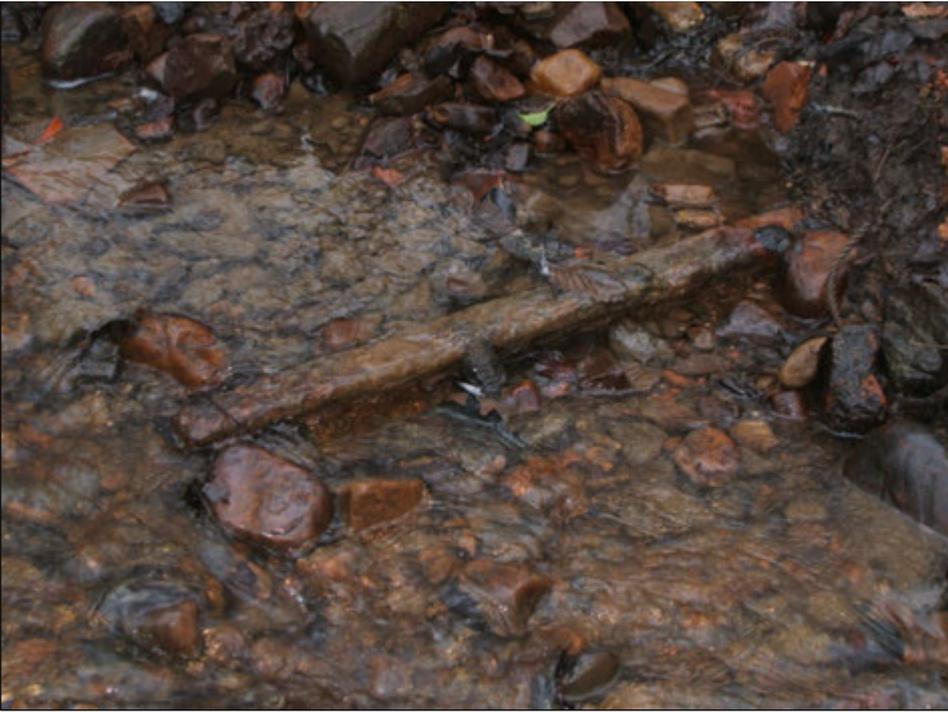
Surviving rail embedded in the side of a drainage ditch on the north side of the bridleway where it is crossed by the railway.
